Seuratograms of Cargo Tank Pitting

Abstract

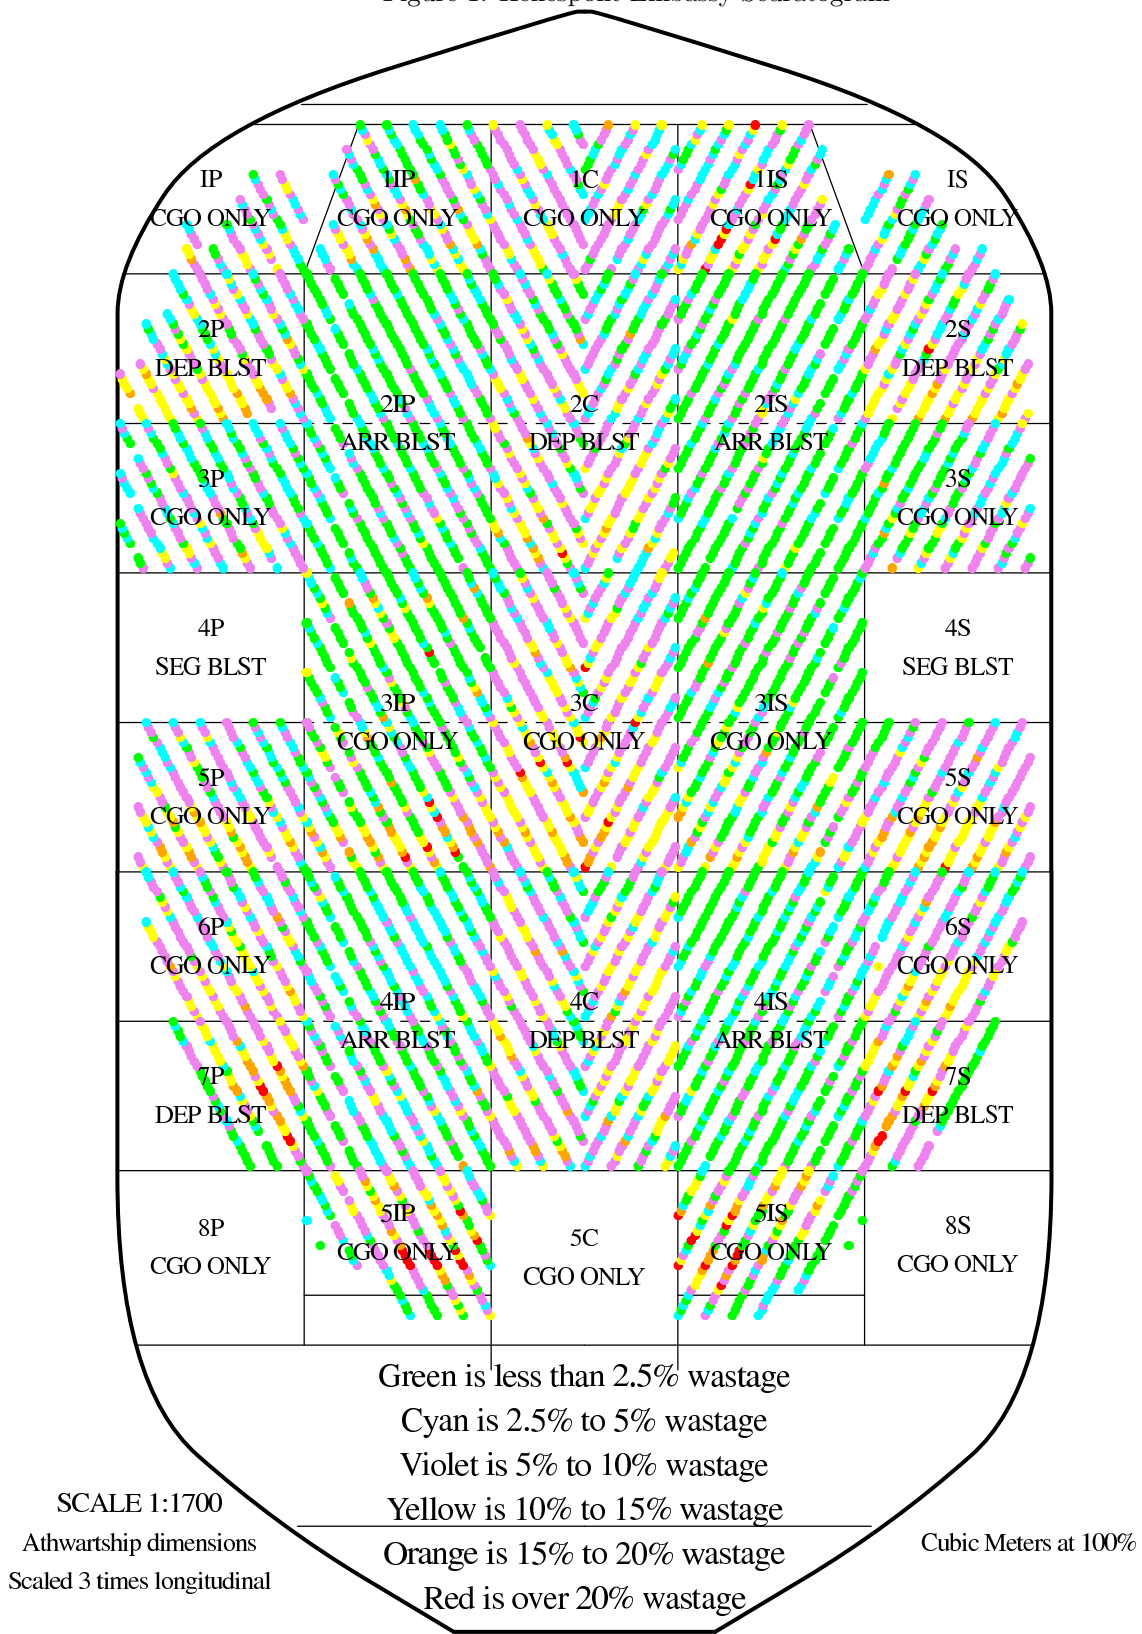
Figure 1: Hellespont Embassy Seuratogram

Figure 1 shows the Embassy seuratogram. In this diagram less wasted areas are shown in cool colors, more wasted in hot colors. The segregated ballast tanks (4P and 4S) which were full coated with the bottom coating in excellent shape were not measured. The other tanks had bottoms which had always been uncoated. Only the flat bottom portions were measured ruling out portions of the 1, 2, 6 and 7 wings and all of the 8 wings. 5C was full coated and not measured. Since all the flat bottom plating was between 28.5 and 31 mm thick, — almost all 28.5 mm — percent wastage is a good proxy for absolute wastage. On this ship 10% wastage is about 3 mm. Figure 2 is the overall percent wastage distribution.

On average, the forward most frames in the long tanks had one third the wastage of the aftmost. This longitudinal dependence can easily be seen in the seuratogram. One result is that there is a milky way of bad wastage at the aft end of 5 wings and the 3 inners and center. This belt of 10.9% (Frame 76) and 10.3% (Frame 77) wastage is in a high longitudinal stress region. This area was missed completely in the ship’s CAPS surveys. Class took girths at Frame 71 (aft ends of 6 wings, middle of 4C and 4 Inners) and at Frame 83 (aft end of 4 wings and middle of 3C and 3 Inners). The average wastage measured in these girths was 3 to 4% but of course many of these measurements were not on the flat bottom.

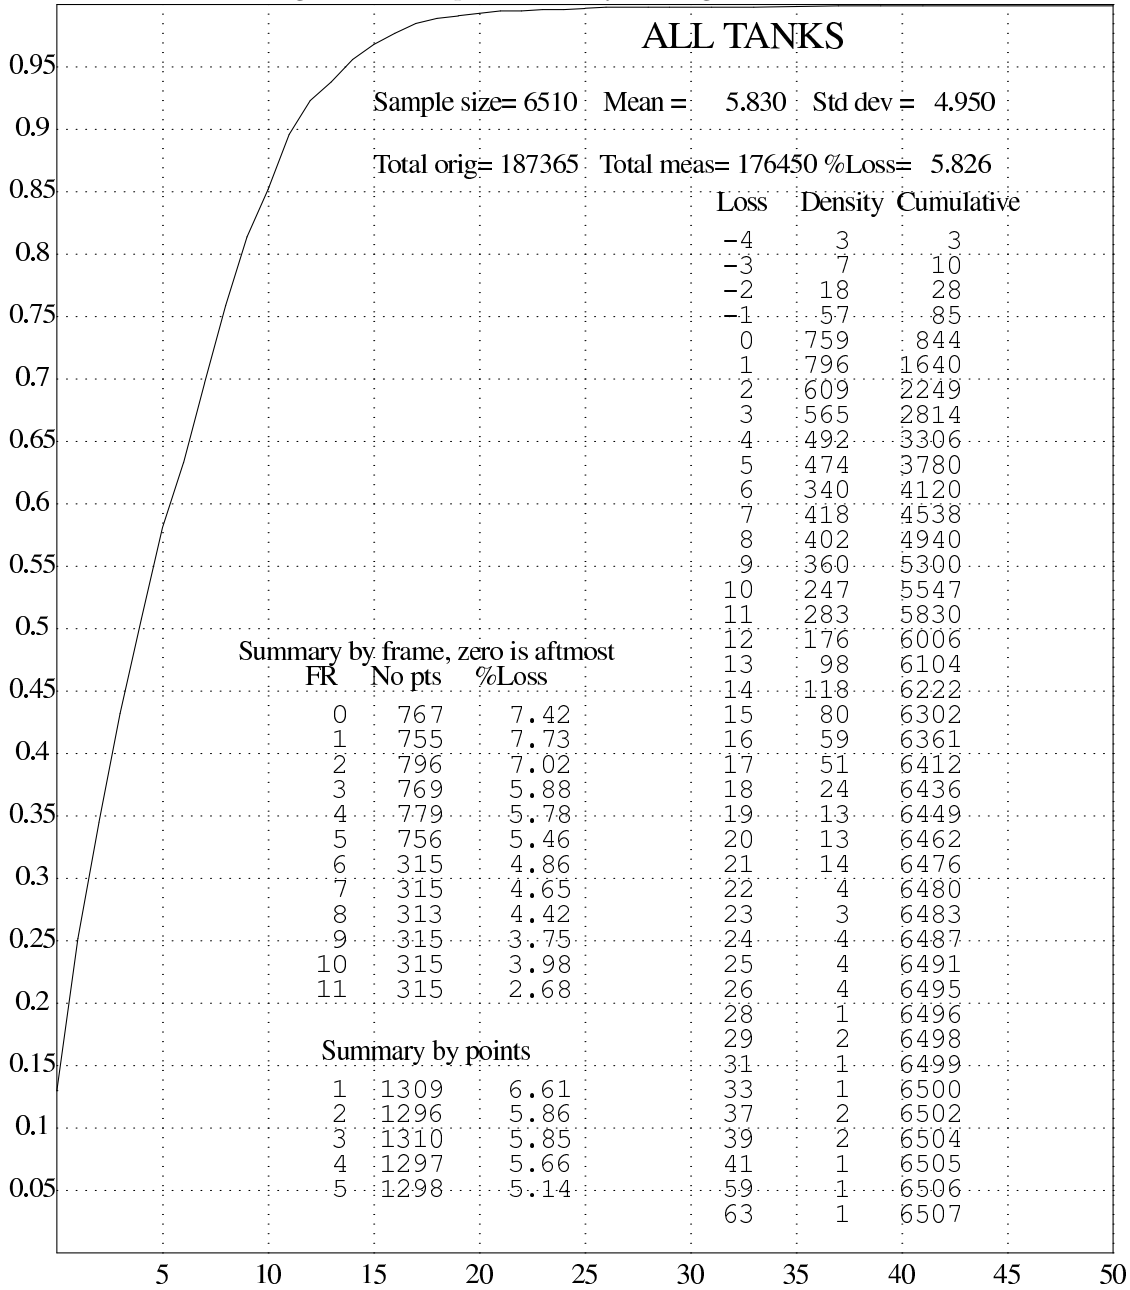
Figure 2: Hellespont Embassy Wastage Distribution, All Tanks

There was some longitudinal variation within each bottom bay. The little table labeled Summary by Points in the lower right corner of Figure 2 shows the aftmost point in each bay (labeled 1) averaged about 15% more wastage than the middle three points, which in turn averaged about 12% more wastage than the forward most point (labeled 5). This probably has to do with the fact that any sludge in the bay tends to end up at the aft end; but, unless the bay is at the aft end of a tank, in a spotty fashion. In any event, the variation is not nearly as strong as the dependence on overall position in the

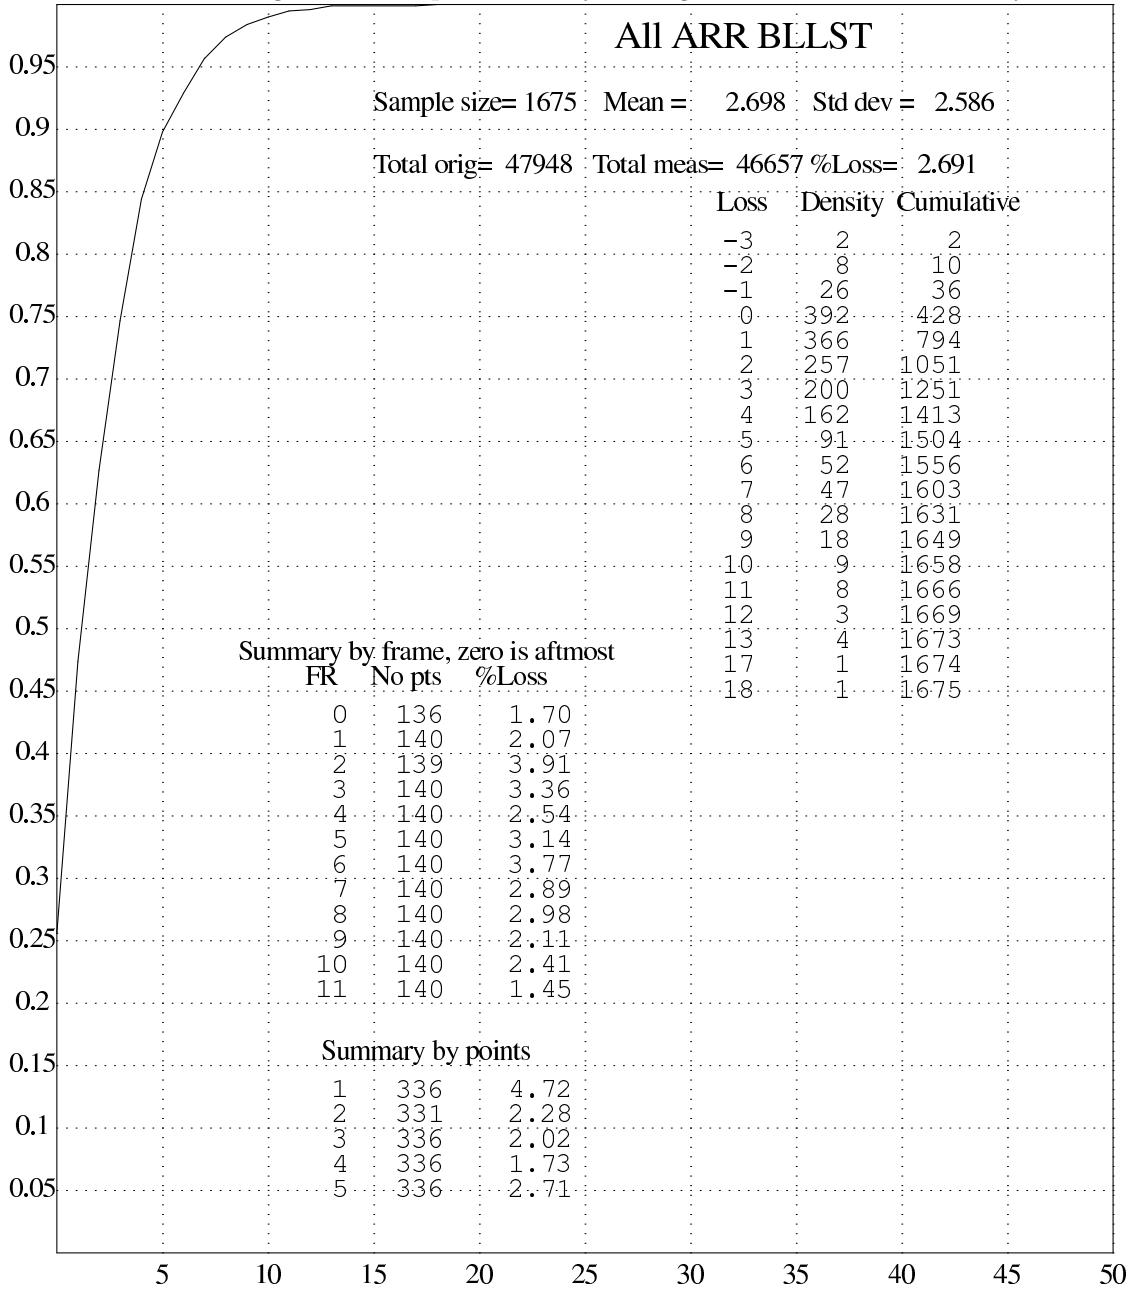
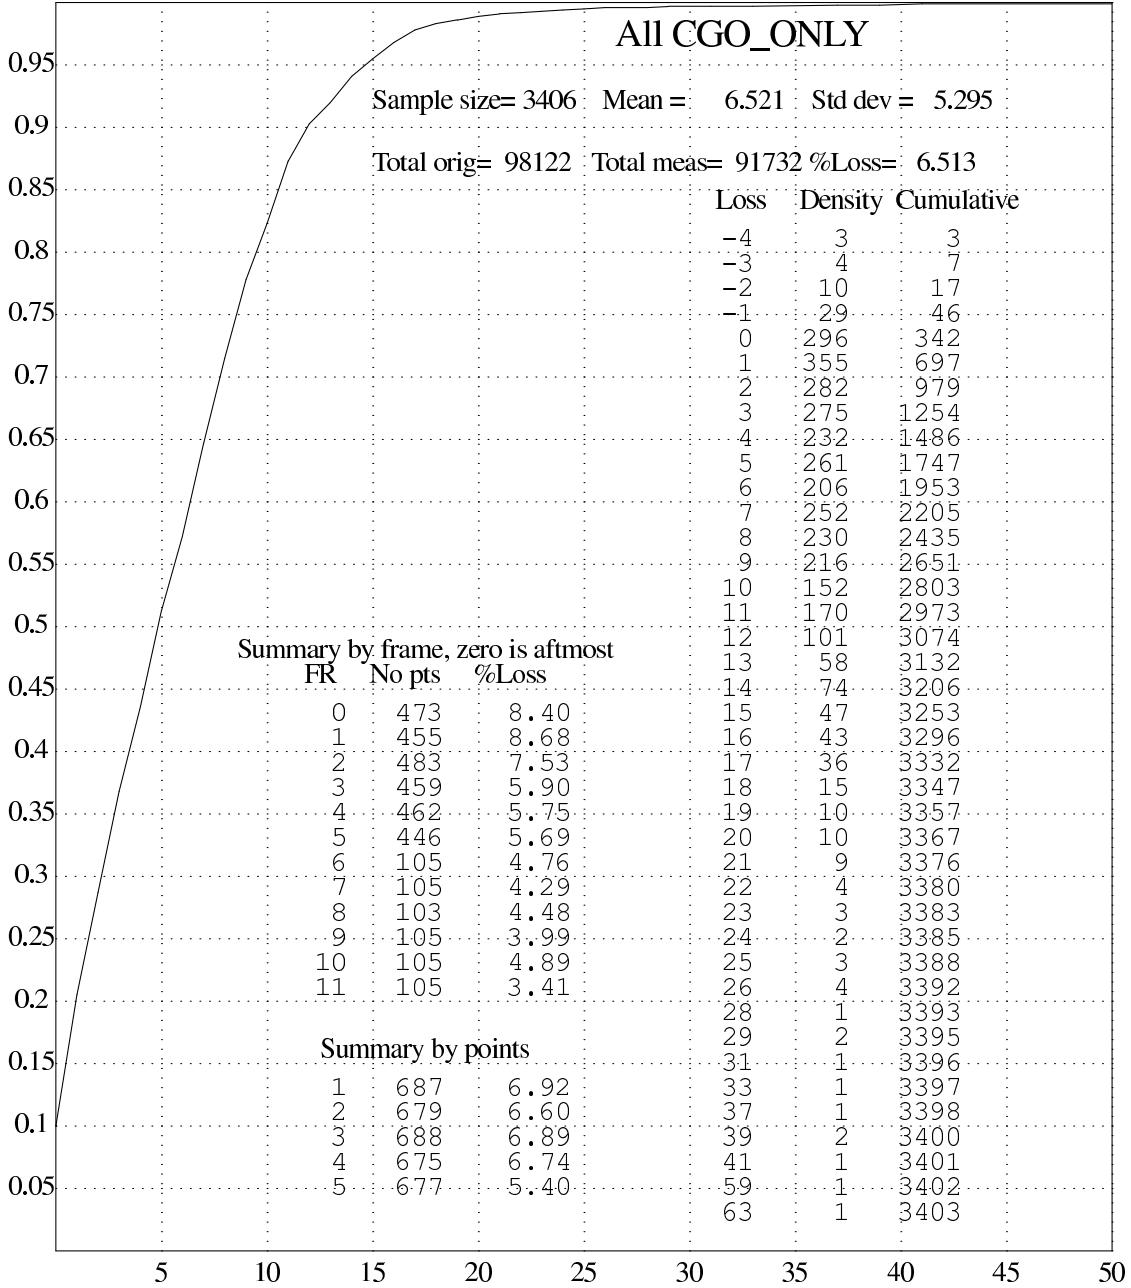
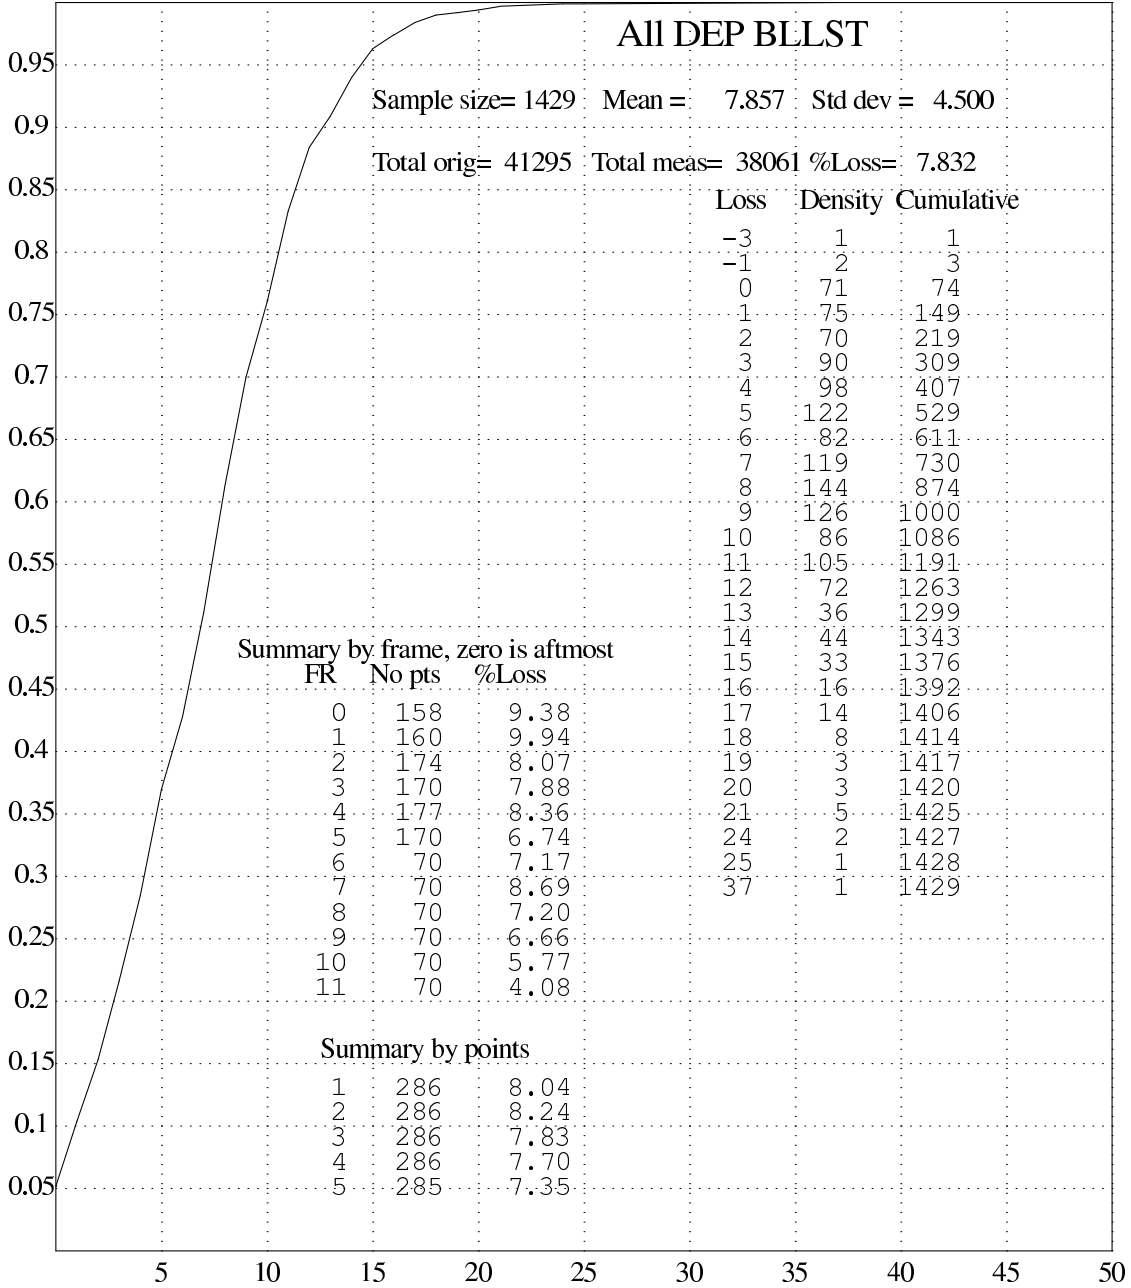
on tank type. Figures 3, 4 and 5 show the wastage distributions by tank type. On this ship, the arrival ballast tanks are 2IP, 2IS, 4IP and 4IS. These four tanks are clearly much less wasted than either the departure ballast tanks (2P, 2C, 2S, 6P, 4C, and 6S), and the cargo only tanks. Table 2 summarizes the Embassy numbers by tank type. The arrivals had a mean wastage of 2.7% less than half that of the other two types. The mean wastage in the cargo tanks was slightly less than that in the dirty ballast tanks, but significantly more variable. Table 3 summarizes the individual tank results, sorted by mean wastage.

In fact, the 1 Inners ranked 8th and 16th in mean wastage, and the 3 Inners ranked 17th and 18th. 3C was the worst in terms of mean wastage. The problem is the eye sees pitting; but it can’t see general wastage. 3C had a relatively low standard deviation relative to its mean.¹ The 1 and 3 Inners (and the arrivals) had relatively high standard deviations relative to their means. The ratio of standard deviation to mean is a very rough proxy for the relative importance of pitting versus general wastage.

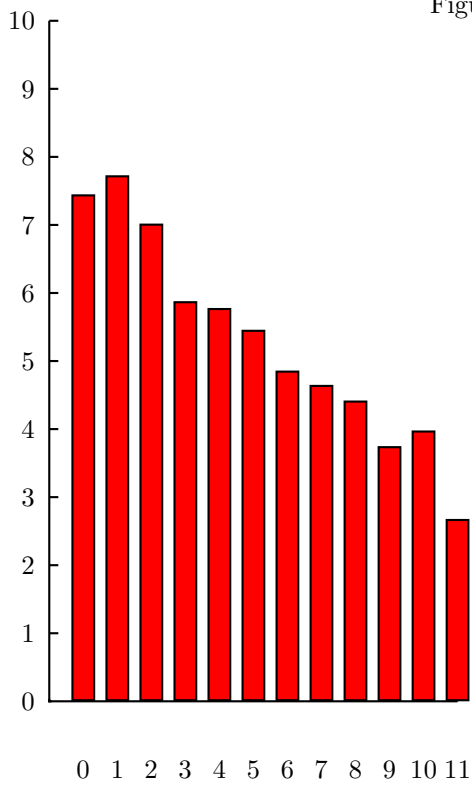
Figure 6: Summary by Frames, Embassy

There was little athwartship variation in each tank, but as expected there was a strong longitudinal dependence. But even here there were a couple of surprises. Figure 6 shows average wastage by frame. In this diagram, Frame 0 is the aftmost frame spacing in each tank, the frame space underneath the stringers. Frame 1 is the next frame space forward, and so on. In all but nine of the tanks, this ship had five webs (six frame spaces). The central nine tanks were double length with a full swash bulkhead at Frame 6.

The surprising feature of Figure 6 is that the worst wastage was not in the aftmost frame, but in the second last frame. We will see that this pattern also shows up in the other two ships. This is strong evidence in favor of the Shell theory of tank pitting. In 1968, Shell published a study of cargo tank pitting.[shell-1968] The work involved both laboratory experiments and field measurements in actual tanks.² They discovered that the steel under sludge was 50 to 300 mV more noble than areas where there was no sludge. The reason was that the sludge was allowing more oxygen to get to the steel beneath it than the liquid covering the clean areas just forward of the sludge. Oxygen is key to the cathodic reactions. Oxygen rich areas becomes cathodic relative to oxygen poor areas. Some of the potentials that Shell measured were of the same magnitude as those created by zinc anodes.

Finally and perhaps most importantly, we cannot see the swash bulkheads in Figure 6. In the double length tanks, there is a full swash bulkhead at the aft side of Frame 6. Frame space 6 is covered by stringers and difficult to clean. It was clearly dirtier than the adjacent frames. If any significant amount of the the corrosion were taking place on the loaded leg, we would expect to see the same sort of oxygen differential cells working in this area as we see at the aft end. But we don't. On the ballast legs, this area is far enough forward so that in the non-ballasted tank it is normally dry, shutting down the cell.³

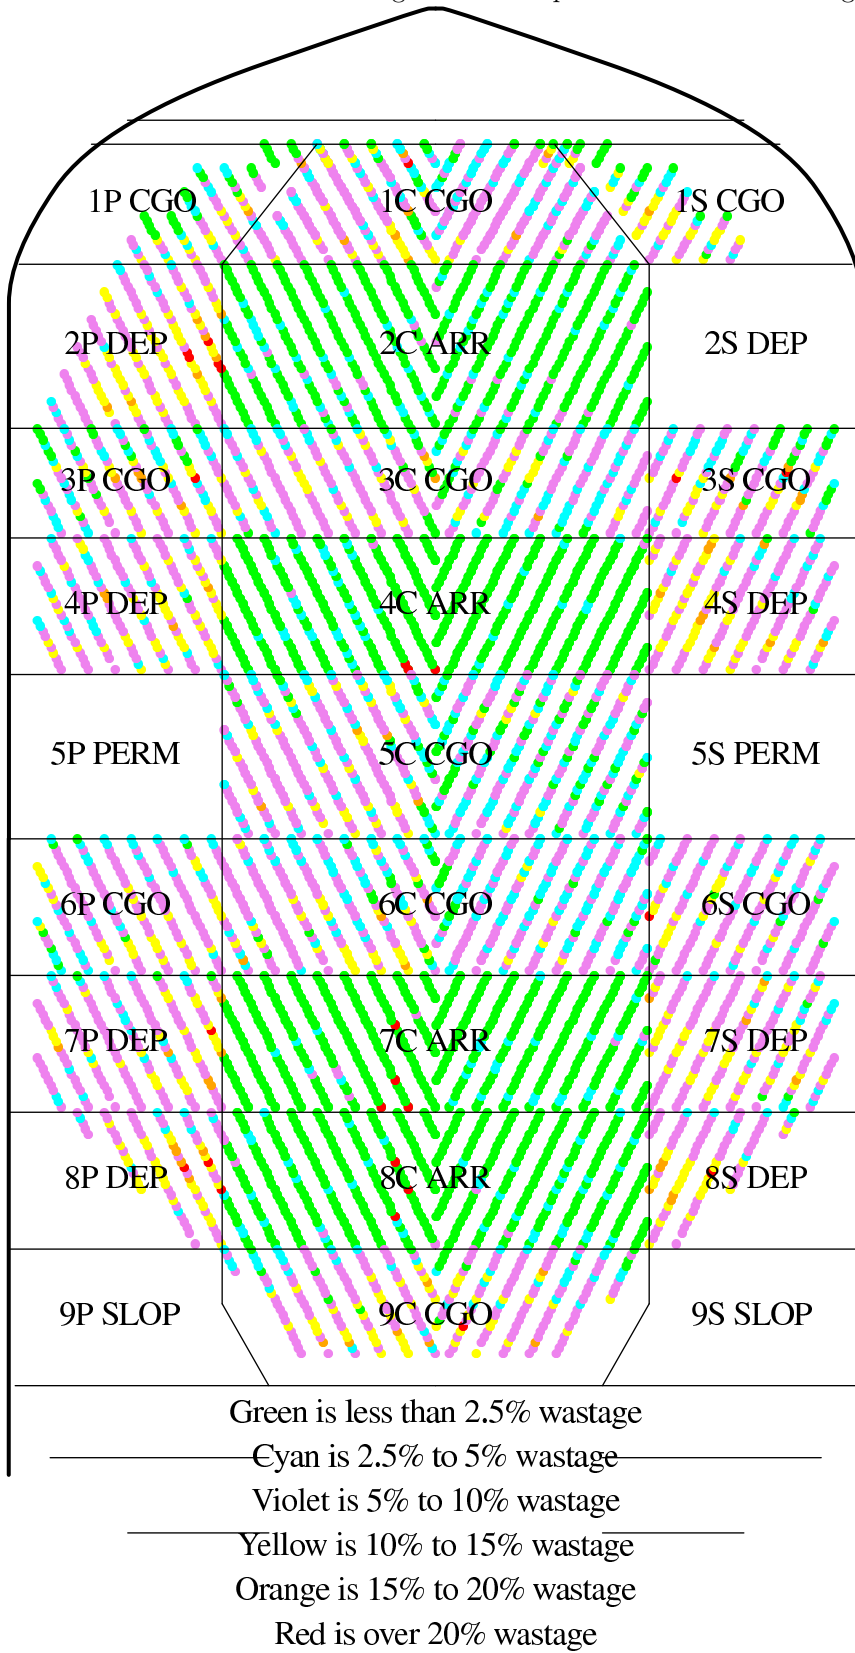
Figure 7: Hellespont Paramount Seuratogram

Figure 7 shows the Hellespont Paramount seuratogram. The Paramount was a 388,000 ton, three across ship built in 1977. There are no stringers in 2, 4, and 7 across. The 3 and 6 across have stringers at both ends of the tanks. The 1's across have stringers on the aft bulkhead. The 5, 8 and 9 across have stringers on the forward bulkhead. Like the Embassy, the Paramount operated mainly on long routes. All the flat bottom plating is 26 mm thick, except the keelson which was 29.5. The full coated 5 wings and 9 wings were not measured, nor was 2S since the program was halted before we got around to this tank. By that time, we had enough data to realize we should blast and coat all the non-arrival flat bottoms.

Once again we see a clear dependence on tank type. On this ship, the arrival ballast tanks are 2C, 4C, 7C and 8C. These tanks are almost all green. The other tanks are mostly violet or worse. Table 4 summarizes the results by tank type. The arrivals had a mean wastage of 1.4%, the cargo only tanks, 6.6%, and the departure ballast 8.8%. In short, the pattern by tank type is similar to that of the Embassy, but even stronger. This is at least partly due to the lack of stringers in the arrivals, making those tanks easier to clean.

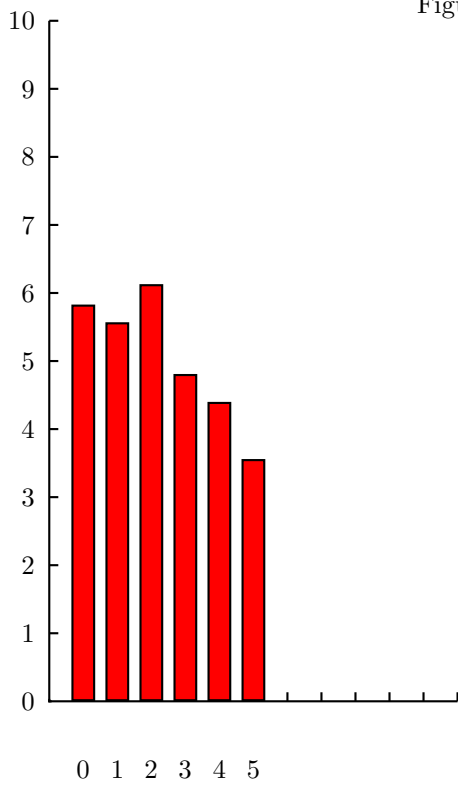
Figure 8: Summary by Frames, Paramount

The overall longitudinal pattern, Figure 8. was also similar, although now the worst frame tended to be the third aftmost. The three across Paramount had much wider tanks than the five across Embassy. Therefore the stringers were much larger. The dirty areas at the aft end of the non-arrivals were more spread out.

The longitudinal dependence is not quite as clear as that for the Embassy. For one thing, the Paramount had no really long tanks. For another, there was so little wastage in the arrivals that it would have been difficult to see a pattern if it existed. The unusual stringer pattern also complicates matters a bit.

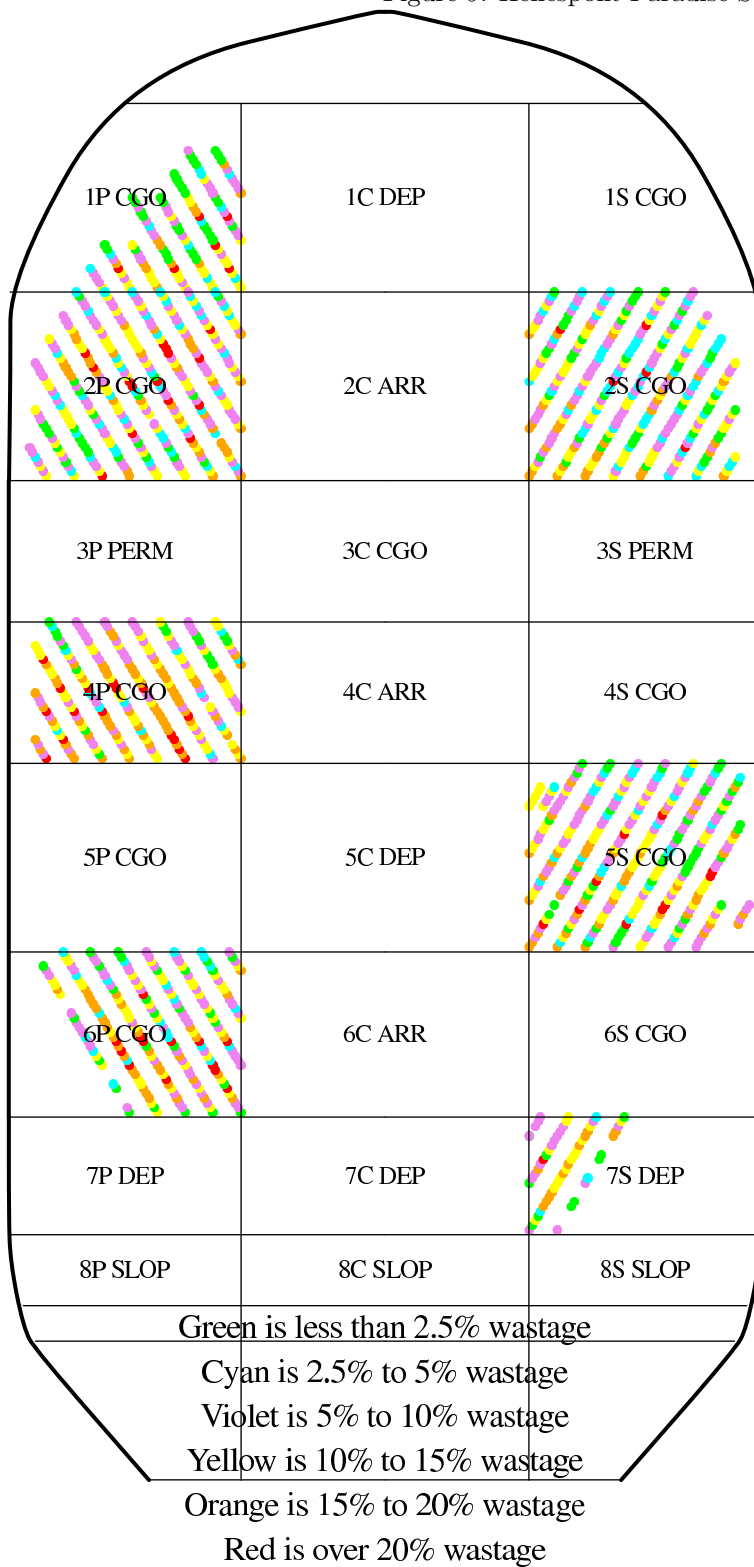
Figure 9: Hellepont Paradise Seuratogram

Figure 9 shows the Hellespont Paradise seuratogram. The Paradise was a 315,000 ton, three across ship built in 1975. In this ships, the stringers are at the forward end of the tank. Most of the flat bottom was 24.5 mm thick, but there was some thinner plate forward and aft, in a few cases as thin as 21 mm. A major mistake in this program was analysing percentage wastage rather than absolute. We strongly

recommend that in the future such measurements be presented in absolute terms.

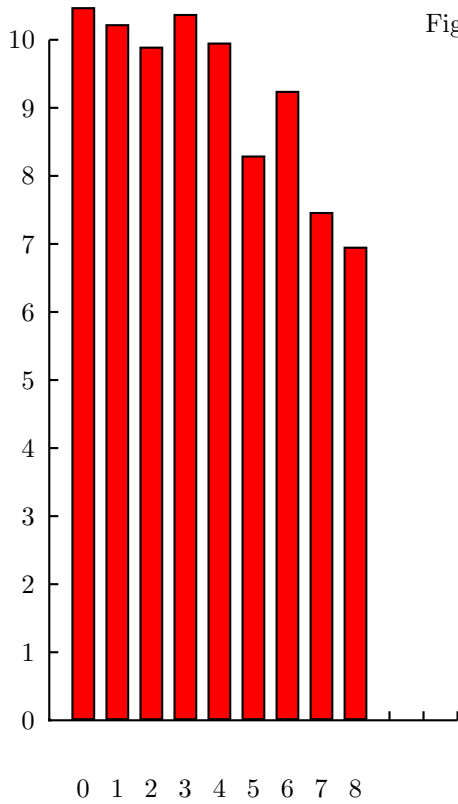
Figure 10: Summary by Frames, Paradise

Figure 10 shows the results by frame. There is some longitudinal dependence but it is not nearly as strong as for the other two ships. All five of the aftmost frames have nearly the same numbers. We suspect that the forward stringer location is important here. There was far less tendency for the sludge to really build up at the aft in these tanks.
